DELAWARE RIVER BASIN  
GREEN VALLEY FARMS DAM  
MRS. ELEANOR M. REYNOLDS

NDI NO. PA-01101  
DER NO. 15-307

CHESTER COUNTY, PENNSYLVANIA  
PHASE I INSPECTION REPORT  
NATIONAL DAM INSPECTION PROGRAM

PHASE I REPORT  
NATIONAL DAM INSPECTION PROGRAM  
BRIEF ASSESSMENT OF GENERAL CONDITIONS  
AND RECOMMENDATIONS

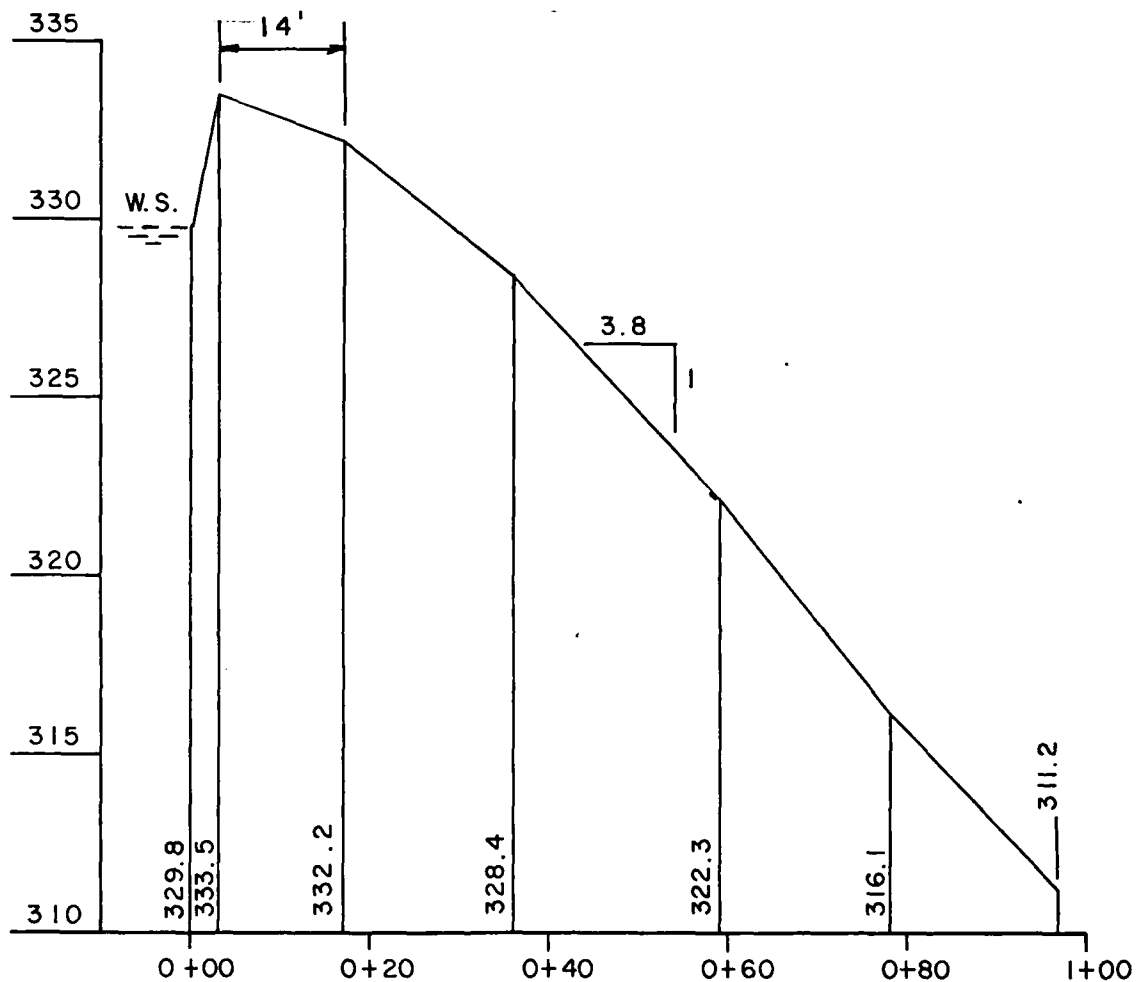
EMBANKMENT SECTION - STA. 5+30

The downstream slope varies over the length of the embankment. The right end of the embankment has a slope of about at 2.5H to 1V. Near the center of the dam at station 5+30 (Plate A-III) the average slope is 3.8H to 1V. The slope has a good grass mat cover. There were no signs of sloughage or seepage. A 30-inch diameter observation well is located near the downstream toe. Two drainpipes, estimated at 6-inch diameter, enter this well. One drain was active. Another pipe discharges the collected water from the well to the downstream area.

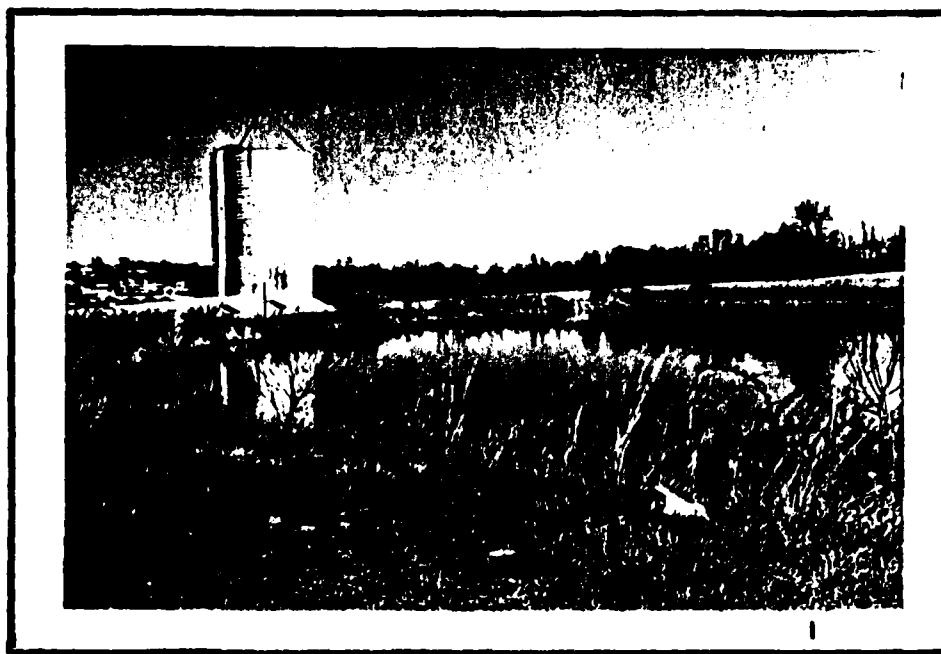
OVERVIEW RIGHT END OF EMBANKMENT - NO. 2

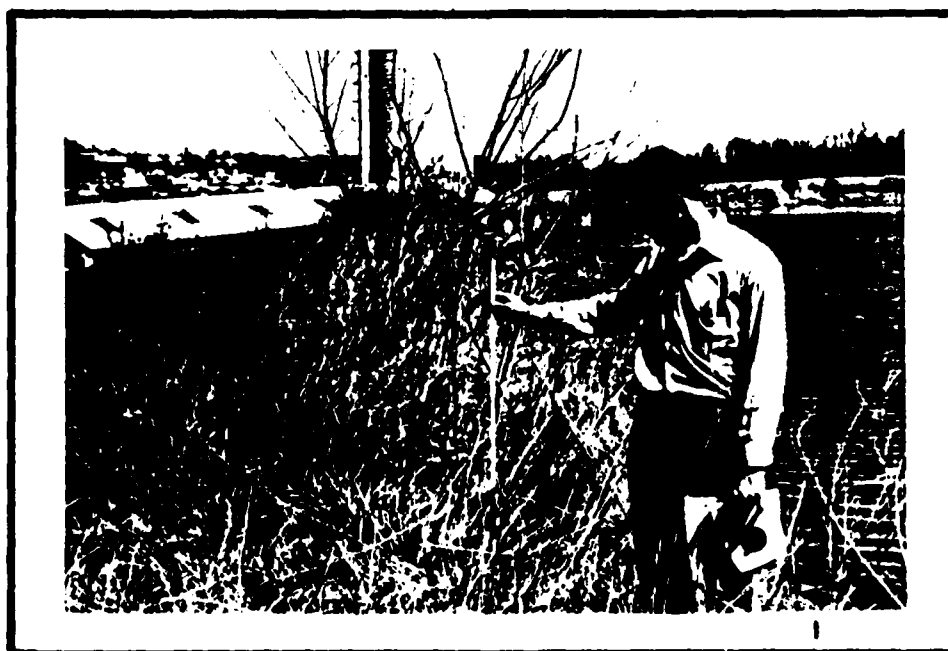
The centerline of the dam was constructed along a curved alignment in its center section with tangents at both abutments (Plate A-I, Appendix A). The crest averages about 14 feet in width and has a good grass mat cover. The typical cross section (Plate A-III, Appendix A) indicates that the crest is sloped down toward the downstream side. The upstream slope has been eroded by wave action over at least half its length causing a nearly vertical three foot high embankment above normal pool level (Photograph No. 5). Weed growth and some brush are located on this slope.

UPSTREAM SLOPE - NO. 5

NOTE: WEEDS, BRUSH AND EROSION FROM WAVE ACTION

The overall visual evaluation of the facilities indicates that Green Valley Farms is in fair condition. Although the crest and the downstream slope have a good appearance, the upstream slope should be protected against wave action and the weeds and brush should be removed. The spillway capacity has been reduced to permit a dry access road to farmland. The 12-inch outlet pipe in the spillway should be cleared of obstructions and the discharge channel should be protected from erosion. The fence across the spillway should be relocated.

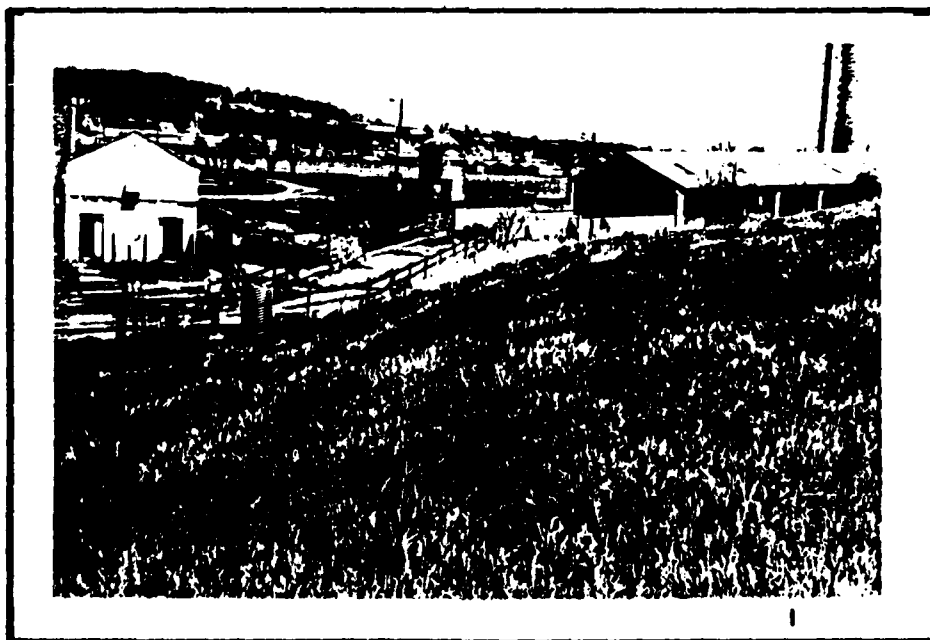
DOWNSTREAM SLOPE - NO. 7  
NOTE: OBSERVATION WELL AND BARNS

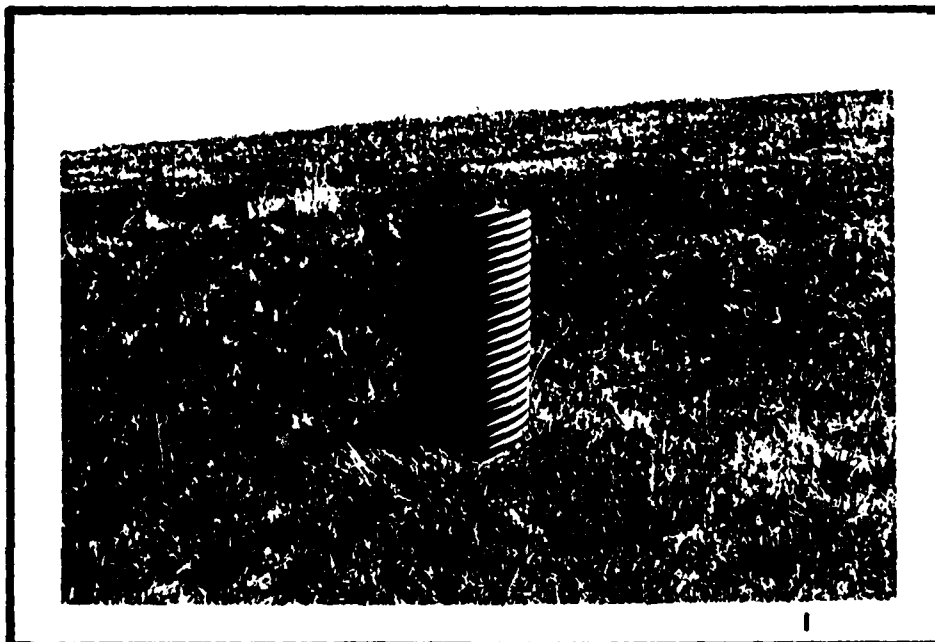
OBSERVATION WELL OF SUBSURFACE DRAINAGE - NO. 9
